Mercury Service Manual

P/N 067S250170-EN Rev A

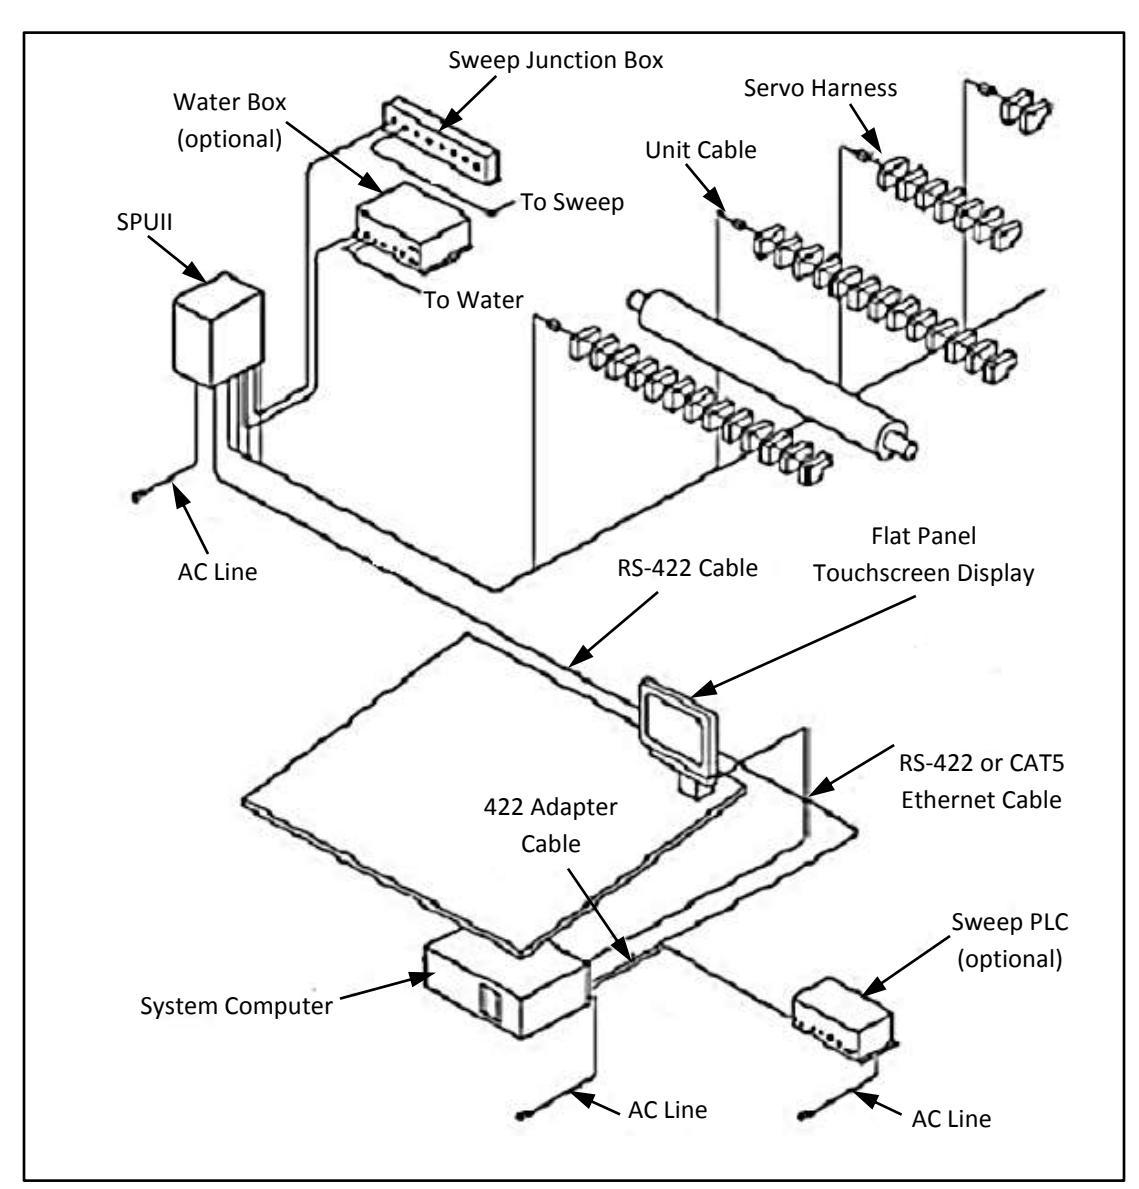
Figure 2.1: Mercury System

2.2 Overview of Mercury System

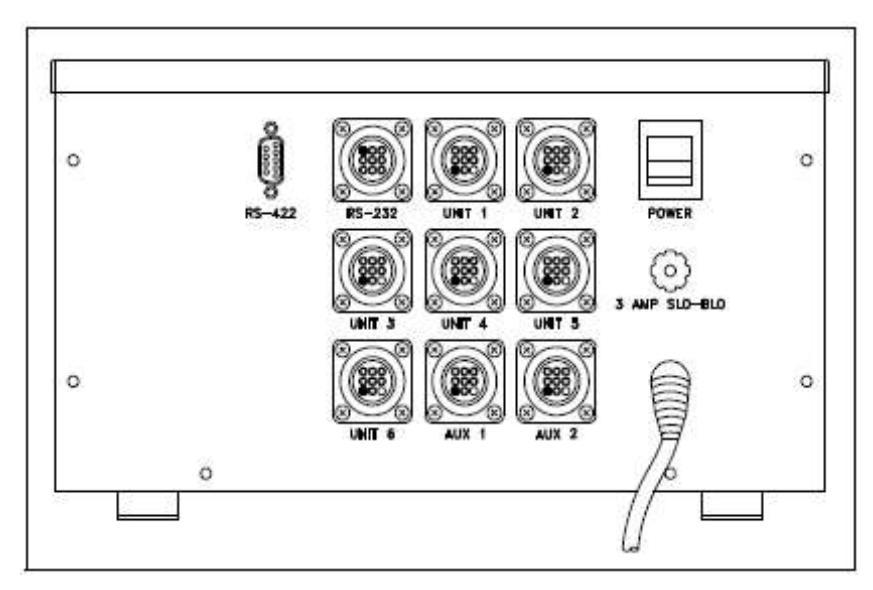
Figure 2.4: SPU II (rear panel)

If the SPU is plugged into a dedicated outlet with a power cord, zero the press and unplug the SPU before proceeding.

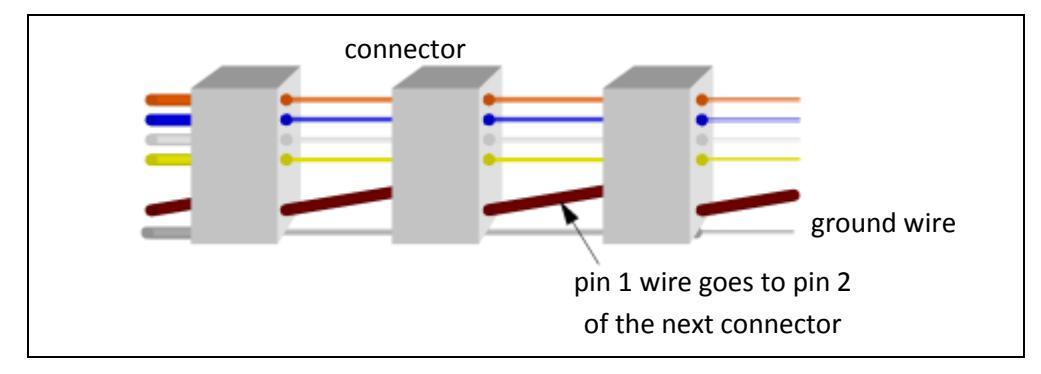
Figure 2.7: Servo Harness

• The wire from pin 1 of one connector goes to pin 2 of the next. An extra ground wire runs the length of the harness and connects at the last servo connector.

- During testing, servos are always numbered with Servo 1 nearest to the unit cable connection.
- **NOTE:** For information about how to replace a servo, see the *Mercury Advanced User's Manual.*

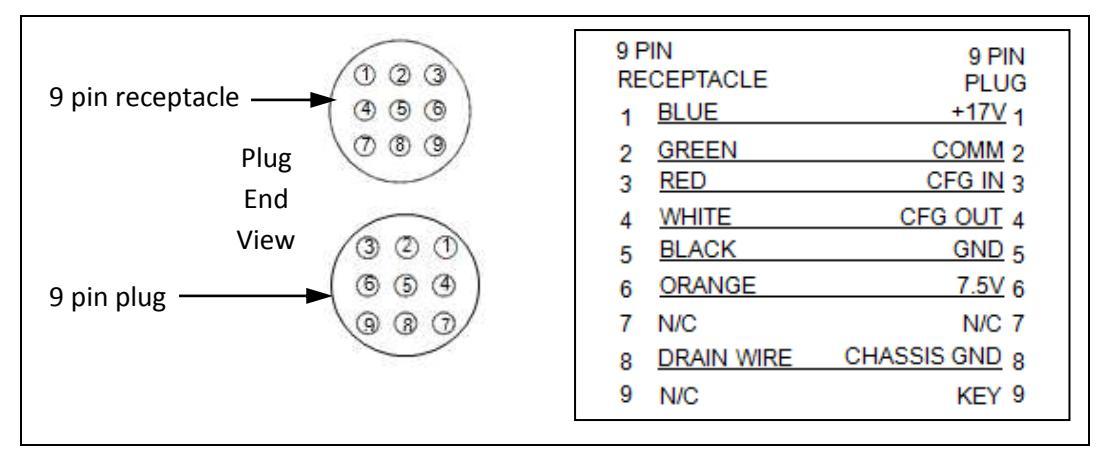
Figure 2.8: SPU to Sweep Junction Box (P/N 050G200128) and Sweep Extension Cable (P/N 050g200032-xx) Pinout and Wire Diagram

The maximum length of the SPU to sweep junction box cable is three feet. Pinouts are the same for the L38 sweep extension cable.

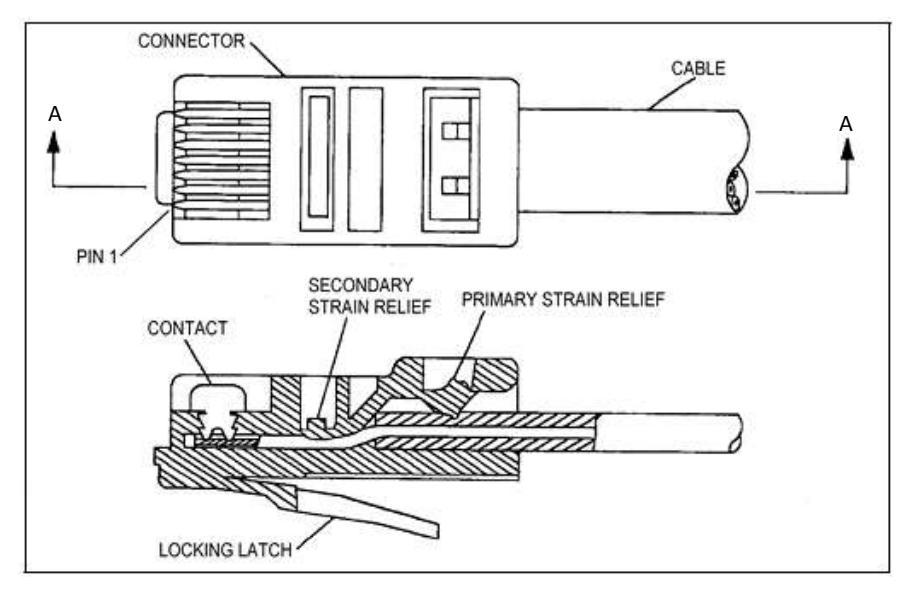
Figure 3.1: RJ-45 Connector (P/N 016G101045)

In the Category 5 STP network, two pairs of the eight wires are used—one pair for data transmit and one pair for data receive. Communications will fail if the two wires of either pair are reversed.

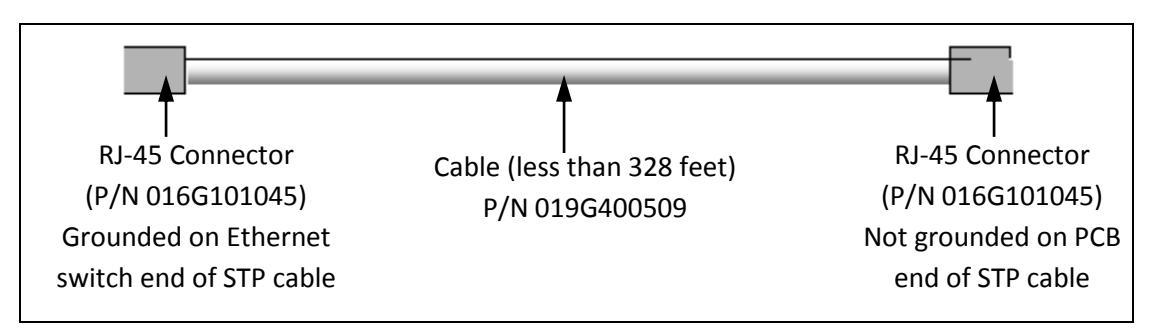
Figure 3.2: Cat 5 STP Cable with Connectors

6 Untwist the conductors and arrange them to match the wiring table shown below. Trim conductors evenly to 14.29mm (9/16"). Maintain tight twists at the termination points to avoid excessive near-end crosstalk (NEXT), which impairs data communications and results in a high number of errors.

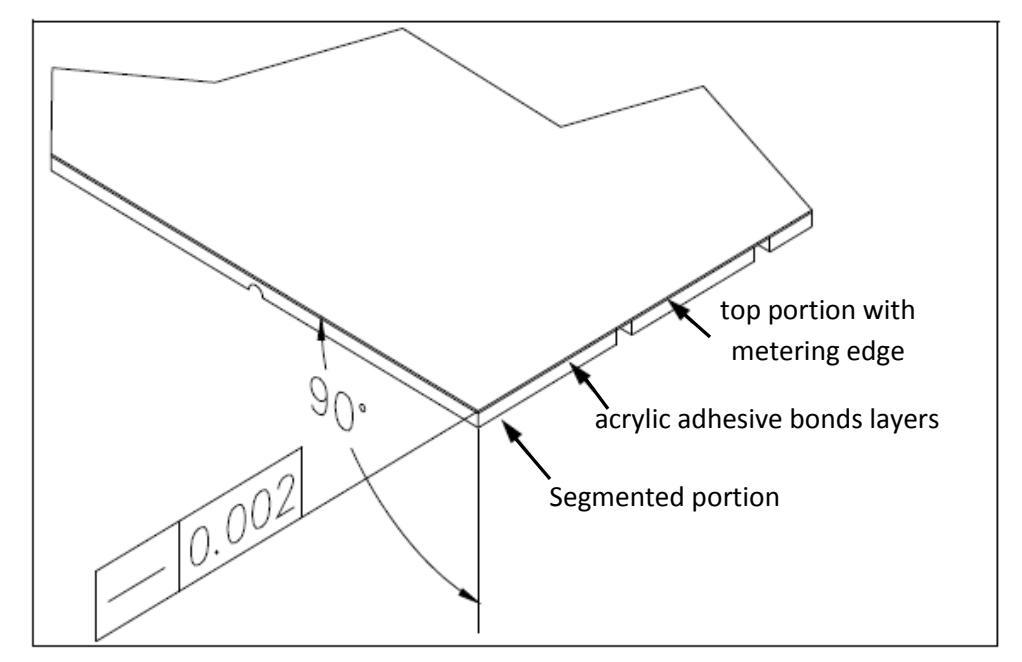
Figure 4.1: Segmented Fountain Blade

A worn segmented fountain blade can be restored by grinding the metering edge to remove the worn area.

A segmented fountain blade includes a top portion with a metering edge, and a segmented portion. An acrylic adhesive bonds the portions together.

WARNING: Do not overheat the blade. Temperatures above 170° F (76° C) will cause the blade to fail in service. When it fails, it will delaminate.

Recalibration can compensate for most fountain blade wear. Eventually the blade may wear so much that it needs to be reground to restore the metering edge. This extreme wear is easily visible as a worn away edge, usually at the ends of the blade.

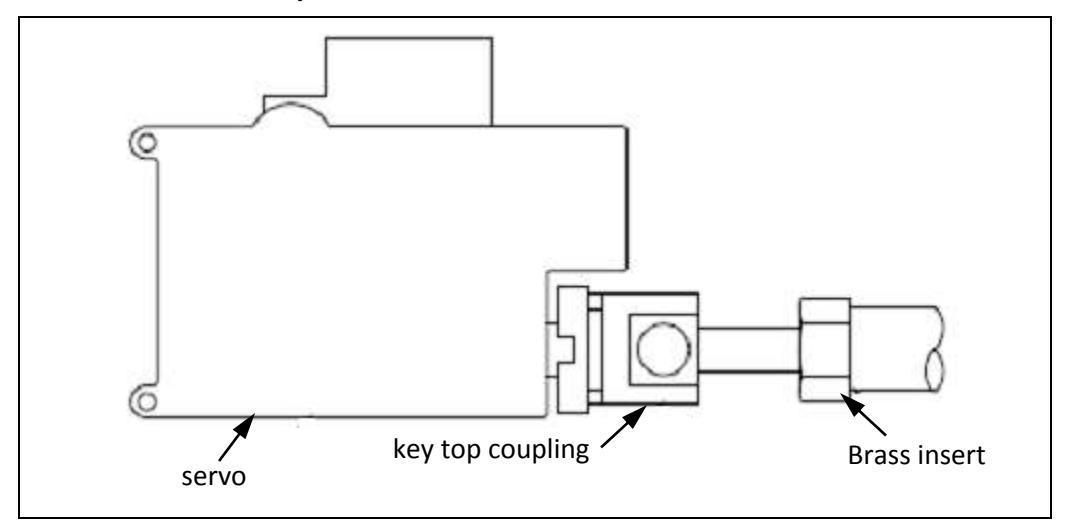
Figure 4.3: Adjustable Insert

Most ink fountains use adjustable inserts as shown below.

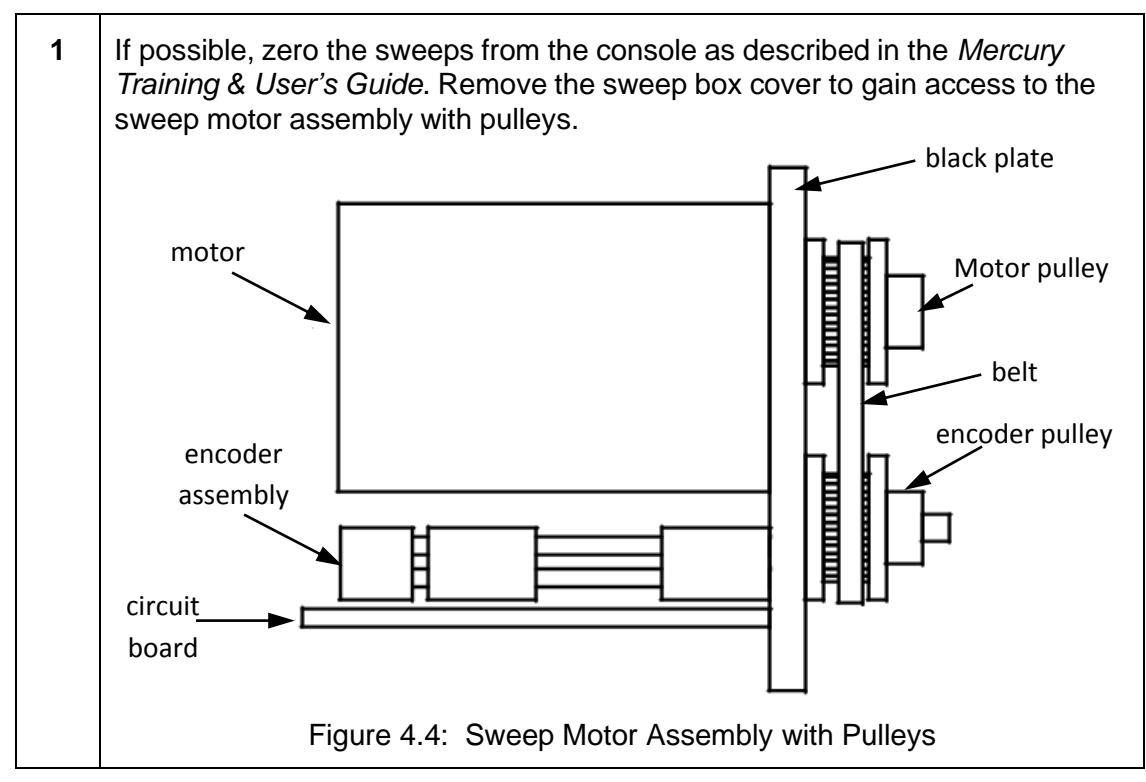
5.4.1 Part 1: Remove Parts and Adjust Pulleys

2	Loosen the screws attaching the back plate to the sweep housing. Relieve the tension on the drive belts and remove them. Unplug the motor assembly connector from the sweep cable.
	NOTE: The sweep may have a hi-flex ribbon cable that attaches it to a small transition box. If this is the case, remove the transition box cover and unplug the ribbon cable.
3	Remove the screws loosened in step 2 and then move the sweep motor assembly from its housing.
4	 Locate the pulley that drives the press sweep shaft. Turn it by hand to the press's mechanical zero position. When the shaft hits its stop, reverse the shaft about 1/4 turn so it is not up against the stop. NOTE: You can use the press's original scale to find the zero position or compare the position to a sweep from a different unit that is at the zero position. Some presses may need to idle in order for you to be able to turn the sweep shaft.

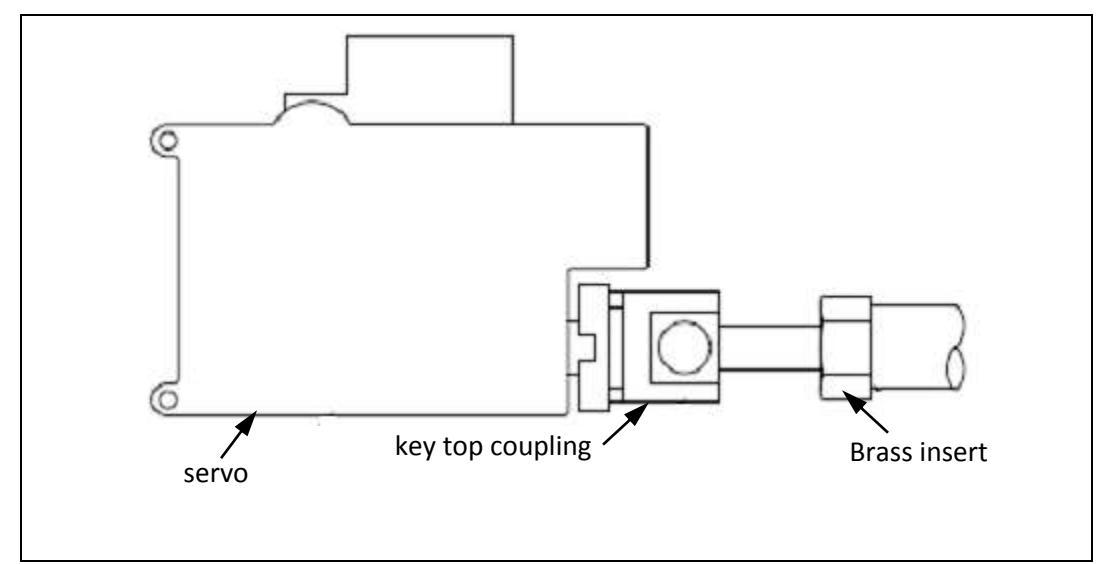
Figure 5.1: Adjustable Insert

Running the Servo diagnostic test (see *Running Servo Test* and the *Mercury Training & User's Guide*) can help locate a faulty servo or one that is not adjusted correctly. If the servo passes the COMM Test (communication), but fails the position test the console shows an error message. This can occur when the brass inserts are too tight at zero and the servo cannot reach its zero position.

1	Note the servo number that was identified during the test. During testing, Servo #1 is always closest to the servo harness connector.	
2	Remove the servo cover. Then remove the problem servo via the two bolts holding it on the rail.	
3	Make sure the ink key moves freely. If not, remove it and clean the ink key and brass insert, or replace the insert.	
	If the key was binding, this could be the problem and not the servo motor.	
4	Connect the new servo, but do not install it on the key top and rail. Let the motor hang by its connector making sure it will not fall off, and that it is connected properly and in the correct direction.

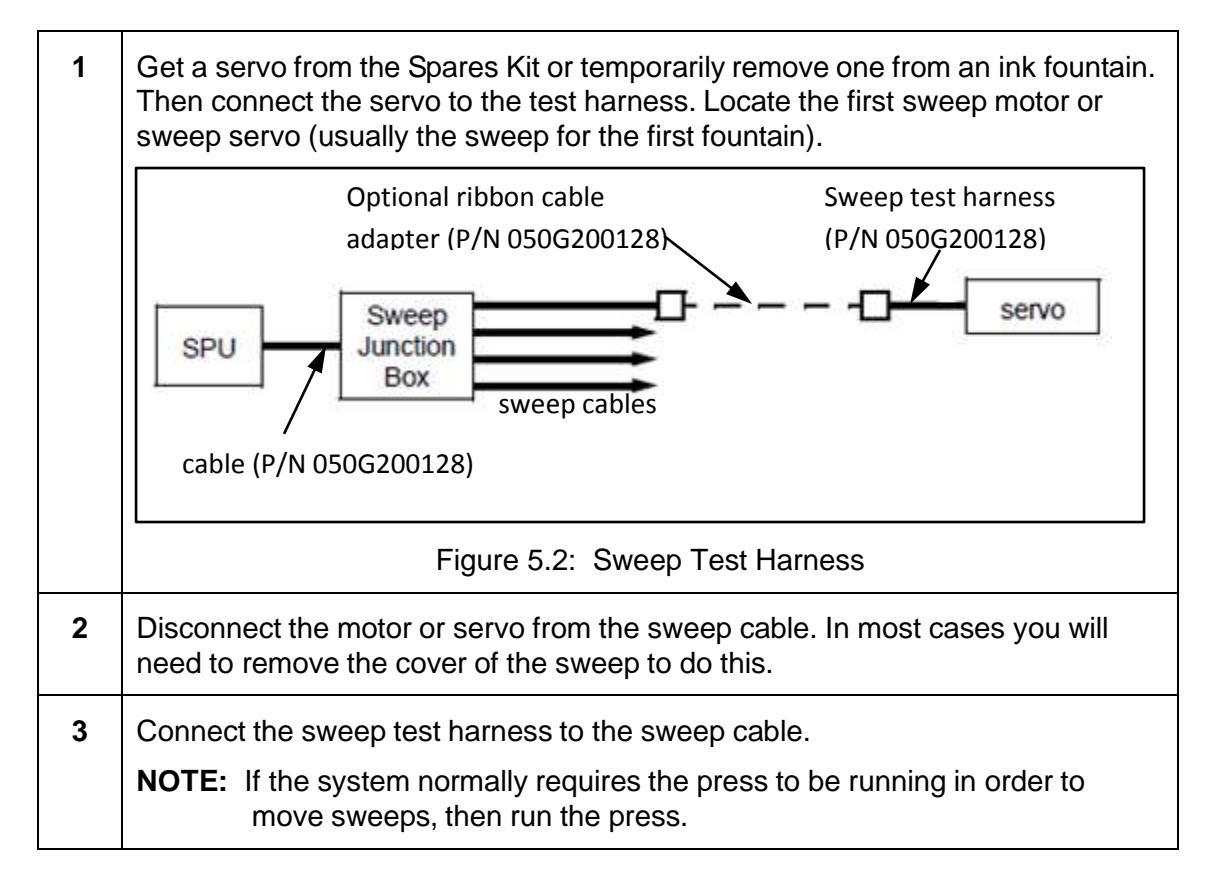
If the Sweep test fails, but cannot locate the problem, there may be a short circuit in the sweep motor or sweep servo. This harness can help you isolate the problem motor. (You can use this cable to locate a problem sweep servo, but it is easier to just replace the servo.)

Sweep Test Harness Results	Action
The servo on the sweep test harness and all sweeps move.	You have located the problem. Replace the motor or servo, and reconnect it to its swee cable. If no spare motor is available, contac AVT Customer Service to obtain one.
	In the meantime, leave the servo test harne in place so that the other sweeps can be controlled from the console. You can manually turn the pulleys for the bad sweep motor until the replacement arrives.
No sweeps move.	Reconnect the motor or servo to its sweep cable. Then connect the sweep test harness the next sweep cable and repeat steps 2-4 above until you locate the problem sweep.
	If you try the sweep test harness for each sweep and none will move, replace the swee cable for the first fountain. See <i>Sweep Cable</i> <i>Problem</i> below.
One or more sweeps move	You have located a bad sweep motor or servo, but there may also be a bad sweep cable. Replace the motor or servo and reconnect it to its sweep cable. Then see <i>Sweep Cable Problem</i> below.

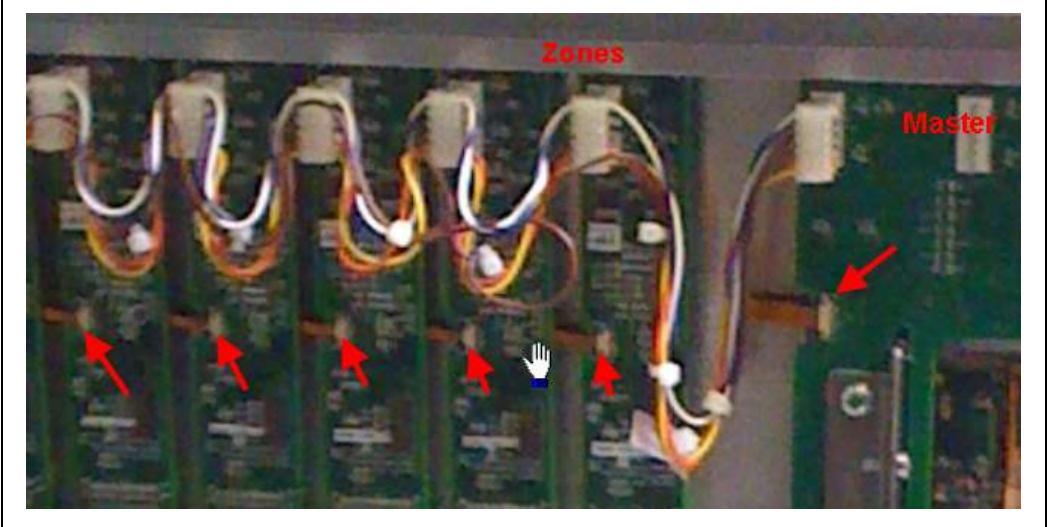
The two controls (UP and DOWN) for each zone PCB are connected by this ribbon cable.

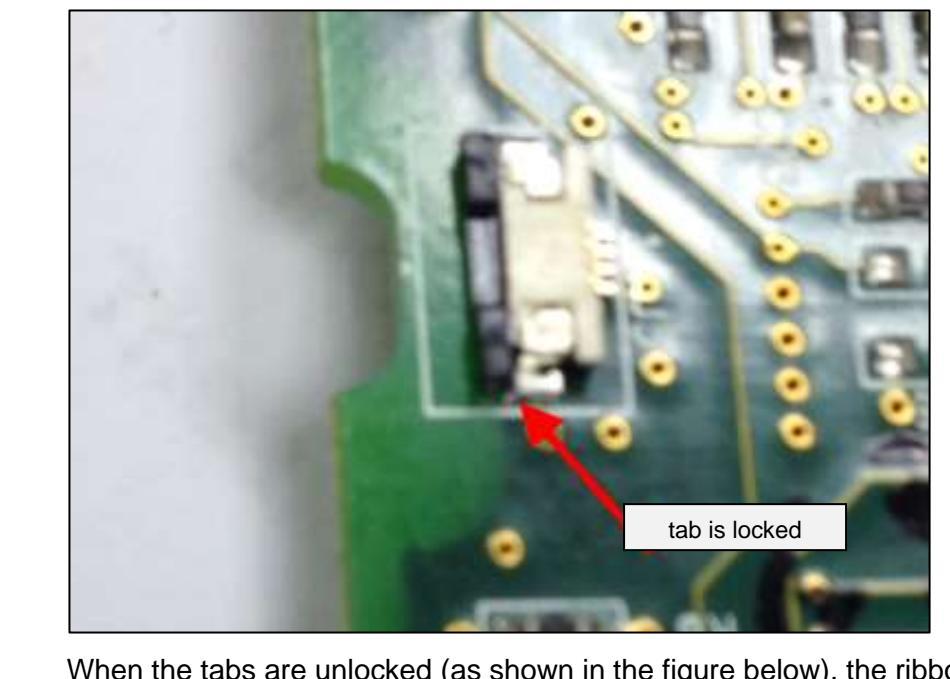
A. Unlock the black locking tab on the left side of the connector, using a small plastic tool. This tab slides to the left to unlock. There are tabs on the top and bottom of the connector.

When the tabs are unlocked (as shown in the figure below), the ribbon cable will be loose.

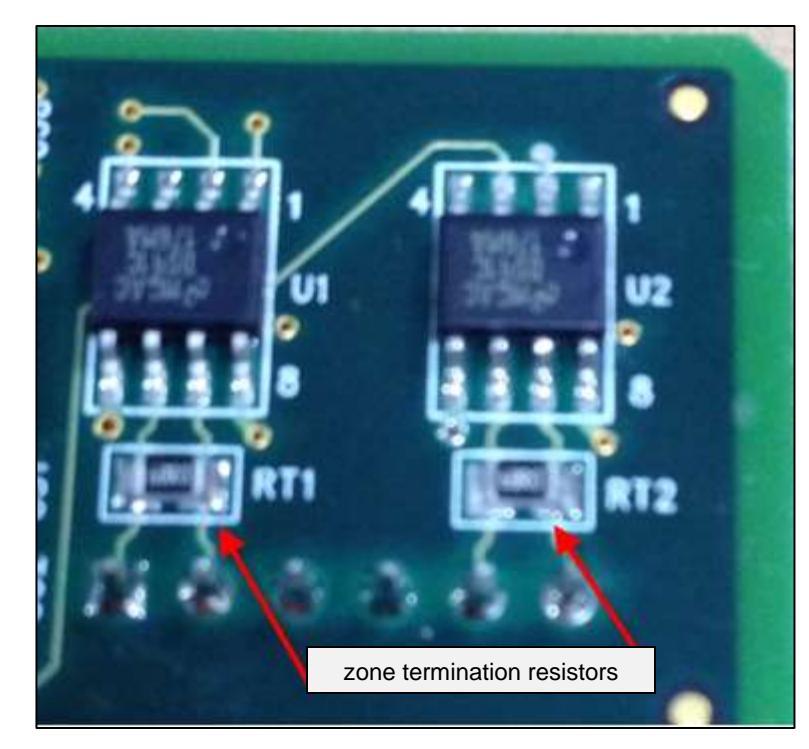
Note: There is a special configuration of zone PCB at position #1. This is the PCB that is farthest from the large Master PCB. This "terminating" PCB should contain two terminator resistors, as shown in the figure below.

This type of zone PCB can only be positioned at position #1 and cannot be used in the other zones.

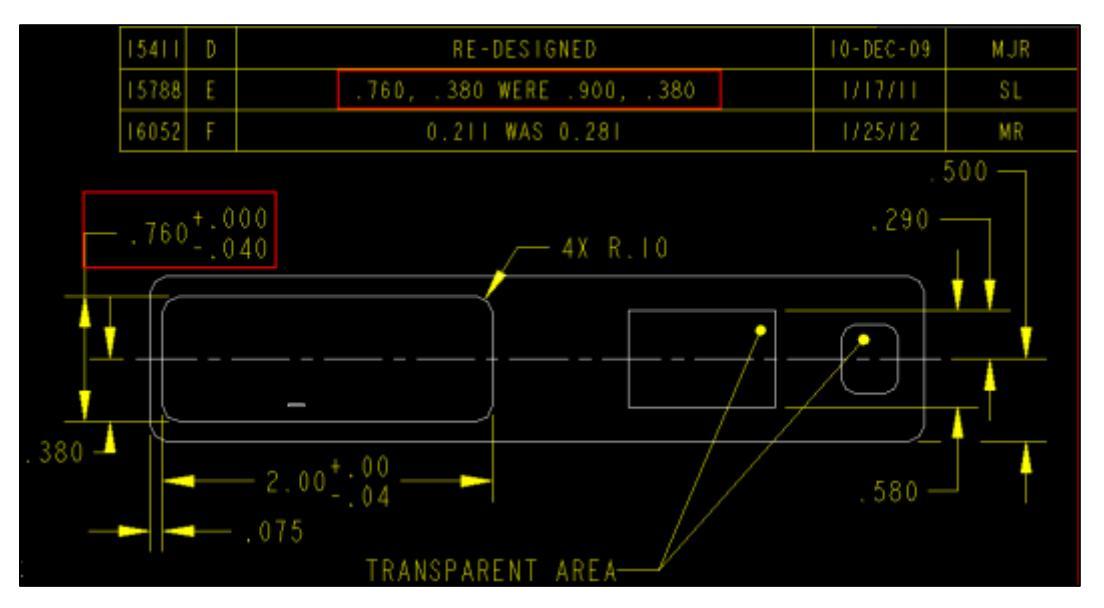
Warning: Switch design change of 035G100615, rev E or later.

The foam back switch changed from 23 mm width to 19 mm width at the start of 2011. Spares of the older style zone overlay will not fit into the new OCU3 consoles (May 2011 or later).

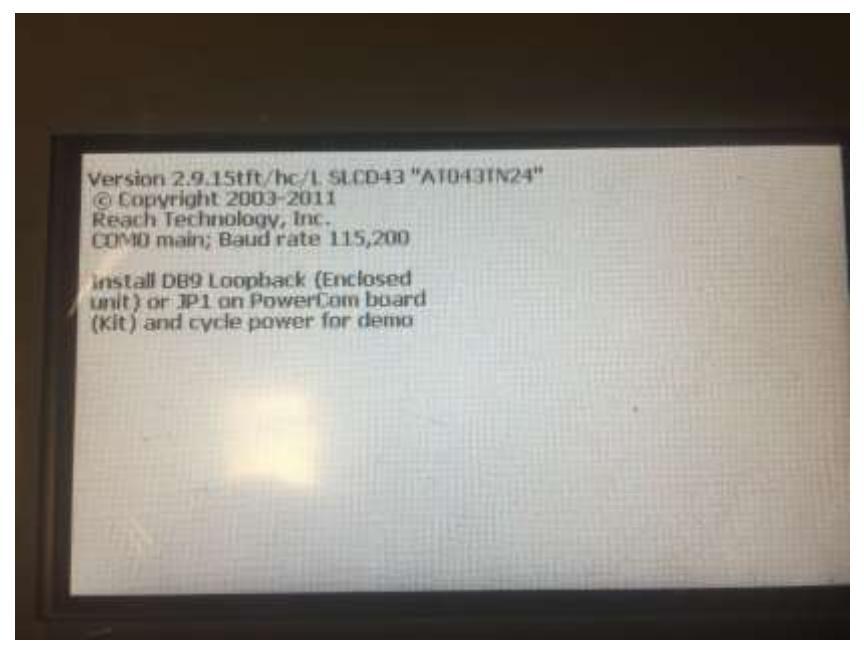
If the power is on and the following is seen on the OCU3 main display for a long period of time, there is a problem with the OCU3 Main PCB assy (050G100294) or the PCB Assembly, REACH display controller (050G100298).

As seen here it powers up, but the Master PCB does not start the display updates in graphics mode.
